BARONESS

Technical Information Leaflet

TIL: 046

LM315GC

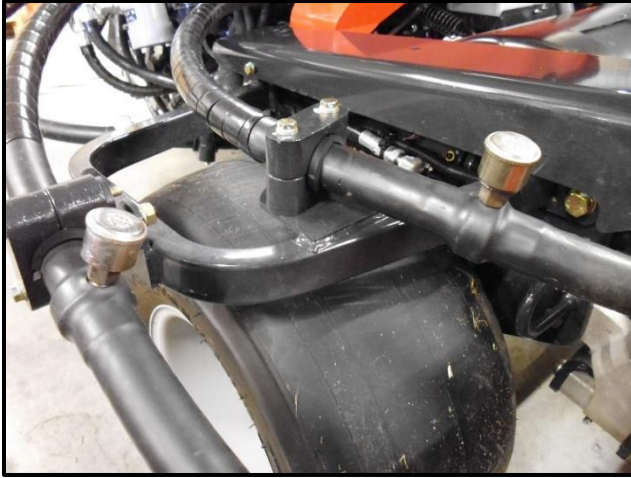
Drive Cable Maintenance & Failure Diagnosis

The LM315GC drive cables should have a service life of about 750 hours.

Regular maintenance is required to ensure that these drive cables last until this replacement period.

If a drive cable fails prematurely then the reason for this failure needs to be investigated before a new cable is fitted.

The cables should be greased daily using the correct type of grease.

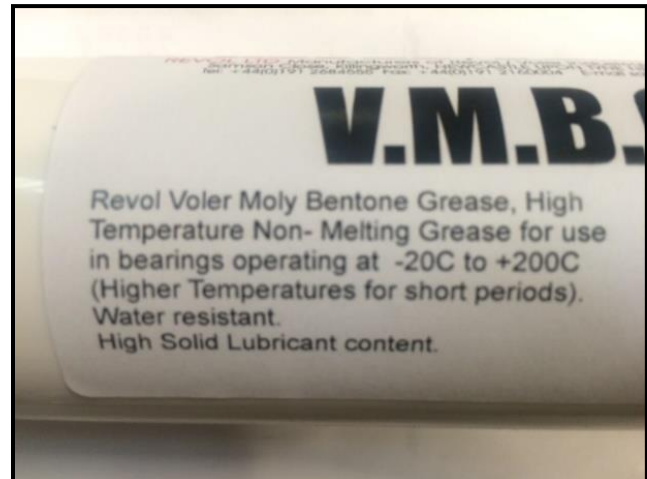
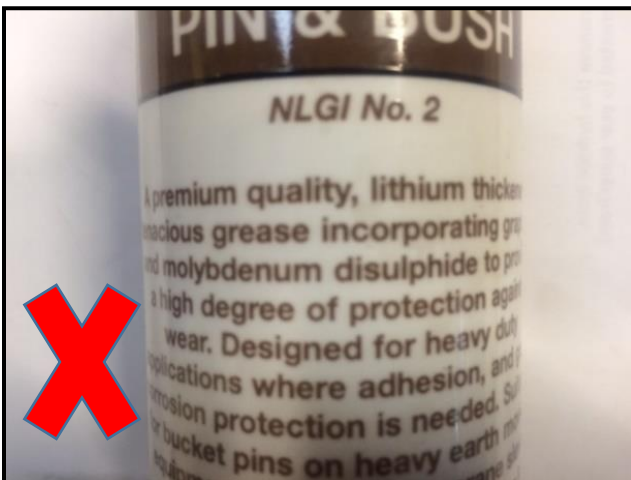
The correct grease to use is a '**Molybdenum Disulphide**' grease that has been thickened using '**Bentone**'.

This is the only grease that will provide the required properties in order to protect the cables.

Note: Bentone thickened grease is a stable grease that does not get thinner as the temperature increases.

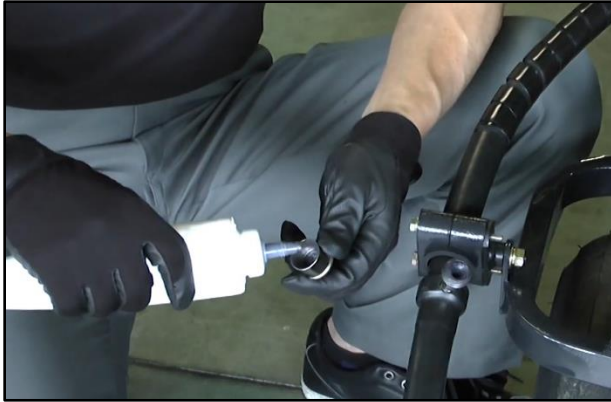
Do not use a Molybdenum Disulphide grease that is thickened with '**Lithium**'.

Lithium is a soap based thickener that gets thinner as its temperature increases. As it gets thinner it loses its lubricating properties and therefore will not protect the cables adequately.

Do not use any other type of grease apart from Bentone thickened Molybdenum Disulphide.

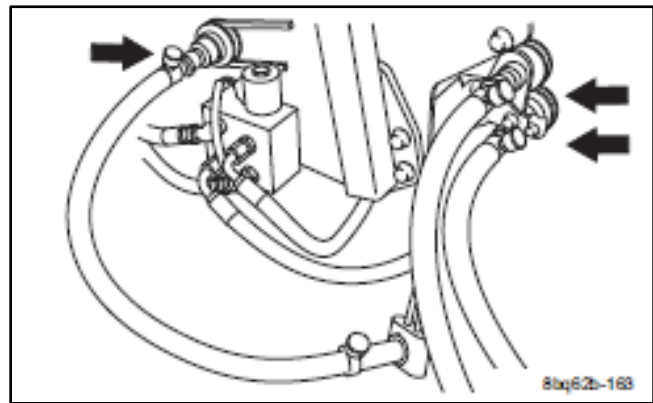
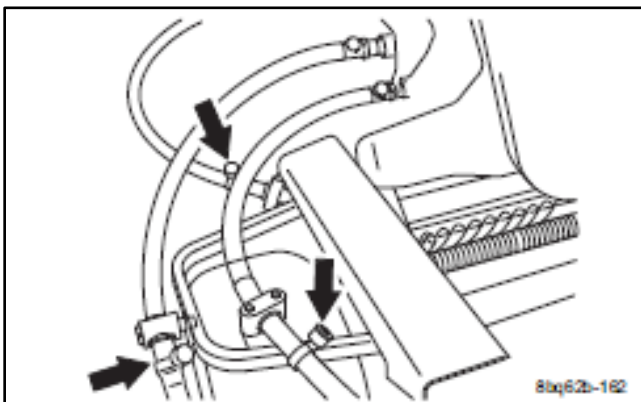
The caps of the grease reservoirs should be filled with **Bentone** thickened **Molybdenum Disulphide** grease as soon as they become empty and cannot be screwed down anymore.

Once the cap has been filled, refit the cap by screwing it on by 2 full turns.

Each of the three grease reservoir caps nearest to the engine/drive belt end of the drive cable need to be twisted by one full turn **every day** before operation. This will inject the correct daily amount of grease into the upper end of the drive cables.

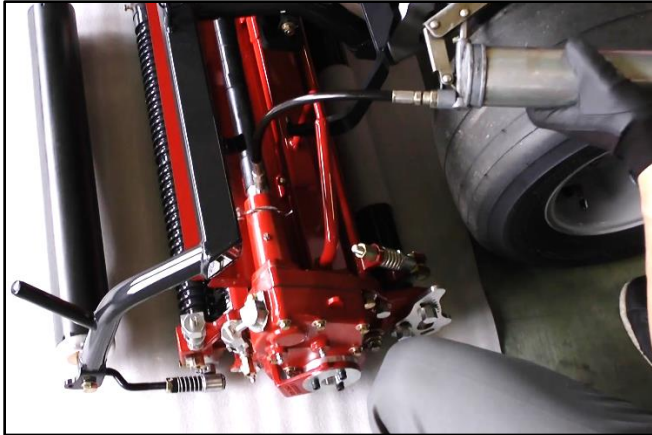
Each of the three grease reservoir caps nearest to the cutting unit end of the drive cables need to be twisted by $\frac{1}{2}$ of one turn **every day** before operation. This will inject the correct daily amount of grease into the lower end of the drive cables.

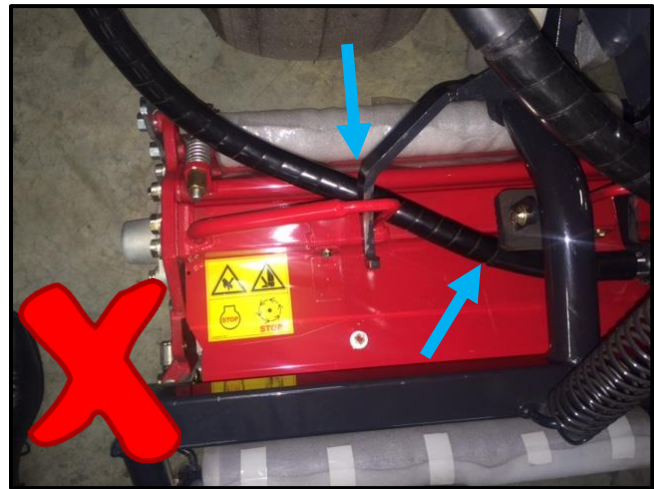
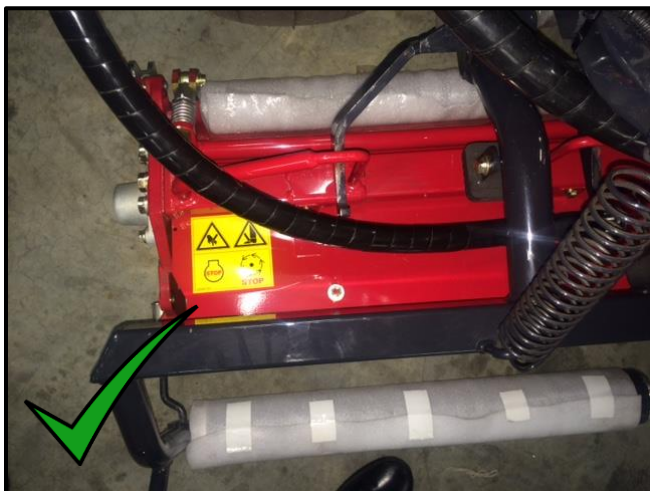
Add grease to the grease nipple on the cutting unit end of the flexible drive cable every 50 hours.

This should be about one pump from a small hand held grease gun (approximate 1 gram of grease).

The grease used on this point should be a No: 2 grade universal EP grease and not a molybdenum disulphide grease as is used on other areas of the cables.

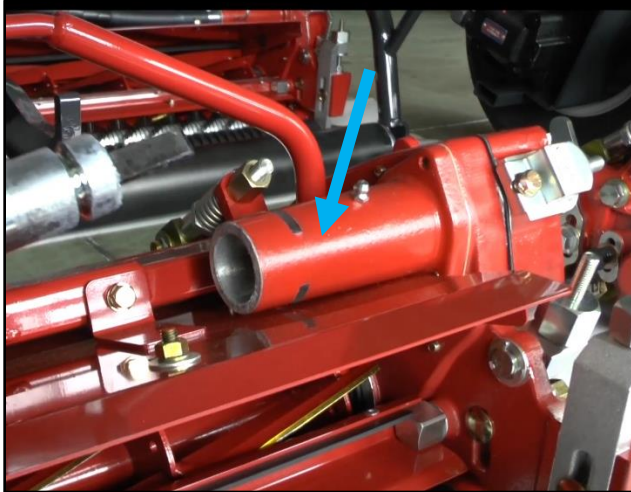
Check that the drive cables are routed correctly.

Make sure that they have no sharp bends caused by incorrect routing.

The cables should be routed with a long smooth curve and must not be able to rub or get trapped by any other component.

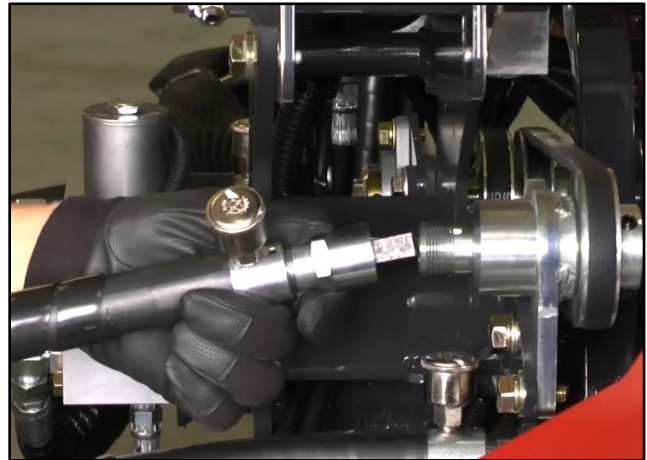
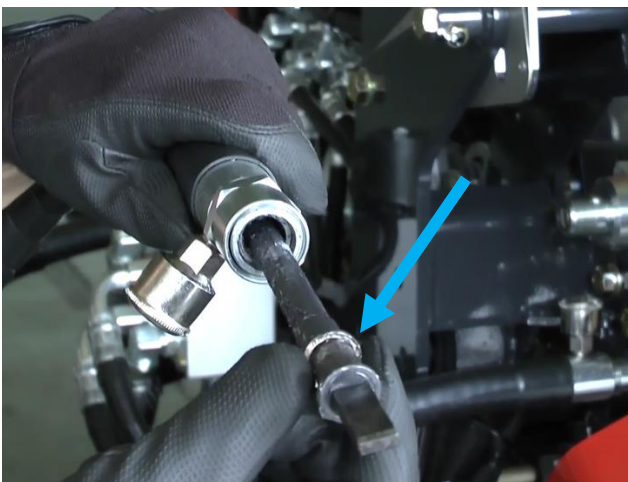
When the flexible drive cable housing socket becomes very worn and the cable fit becomes very loose then the housing socket must be replaced.

If the inner lining of the outer cable becomes worn due to a lack of grease, then a large gap will develop between the inner and outer cables.

This can then allow the inner cable to recoil inside the outer cable which can then cause the drive to the cutting reel becoming disengaged.

If the lining of the outer cables becomes worn, then the outer cable needs replacing.

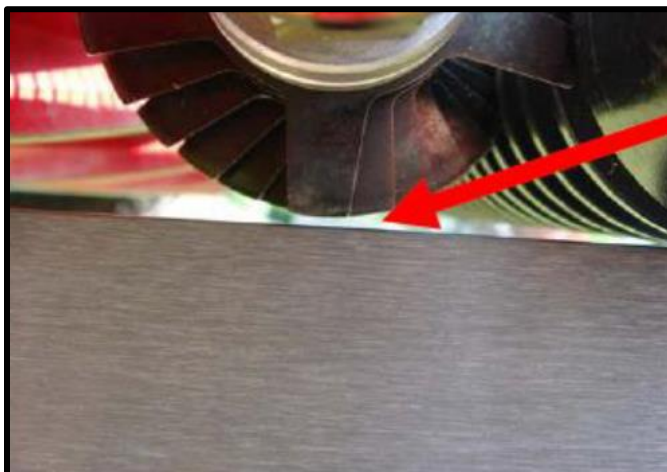
All blades should be kept sharp and should be able to cut with minimal contact.

Increasing the blade contact in order to make blunt blades cut is not acceptable as this will increase the strain on the drive cables.

If the blade relief is badly worn away, then this should be reinstated by grinding.

Make sure that the reel bearings are lubricated and adjusted annually.

Failure to perform these tasks can cause rotation resistance which will put extra strain on the drive cables.

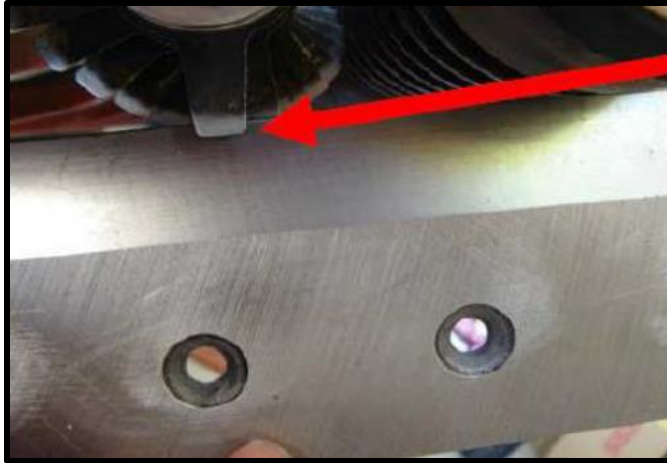
A groomer is not a ground engaging attachment and should never come into contact with the soil layer.

The Groomer should always have a clearance between the tip of the blades and the surface of at least 1.5mm.

If the groomer is set any lower than this, then it will put excess strain onto the drive cables which could result in a cable failing.

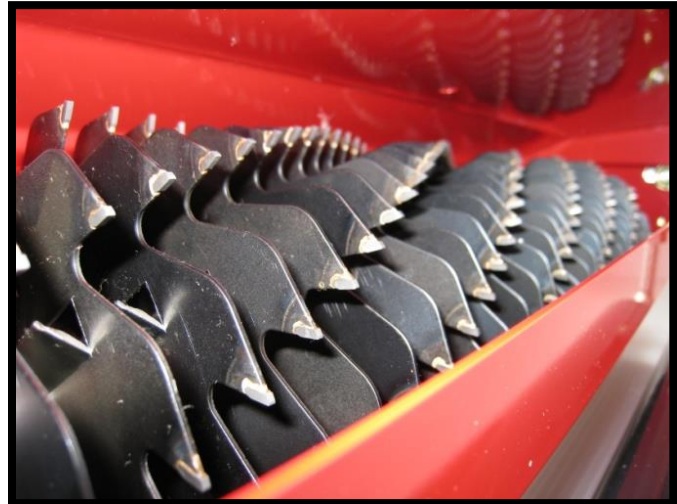
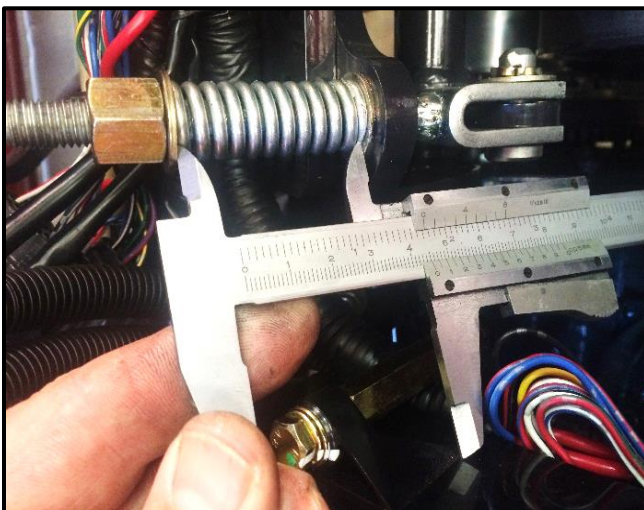
A Dethatching attachment is designed to run within the thatch layer, but it should not be adjusted too deep.

The maximum depth that the Dethatching blades should be set to is 2mm into the surface layer.

If the Dethatching attachment is set any lower than this, then it will put extra strain onto the drive cables which could result in a cable failing.

A Verti-Cutting unit is designed to run within the thatch layer, but it should not be adjusted too deep.

The maximum depth that the Verti-Cutting blades should be set to is 2mm into the surface layer.

If the Verti-Cutting unit is set any lower than this, then it will put extra strain on the drive cables which could result in a cable failing.

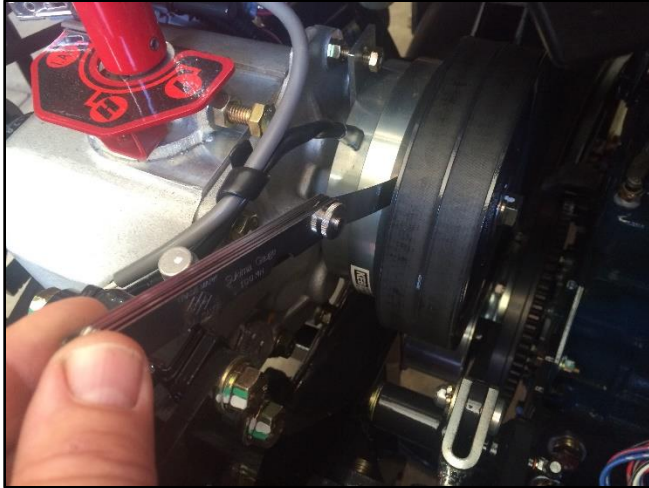
If the drive belts from the engine to the gearbox are too slack, then the belt tension can fluctuate causing the output speed of the gearbox to be inconsistent.

This inconsistent drive speed could put extra strain on the drive cable which could eventually lead to a failure.

Always make sure that the belt tension spring is adjusted to a length of 45mm.

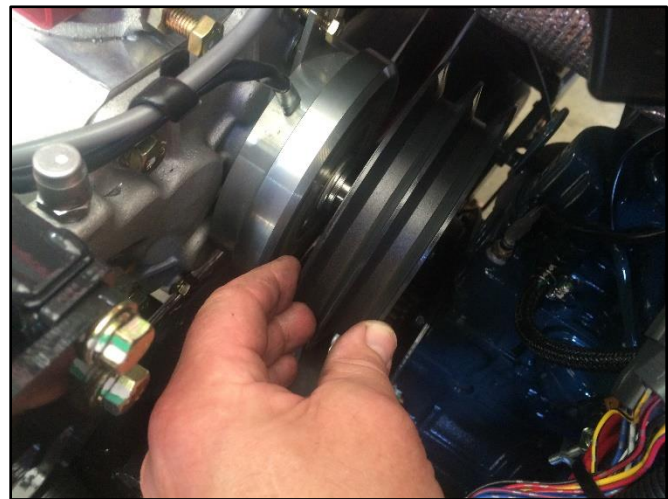
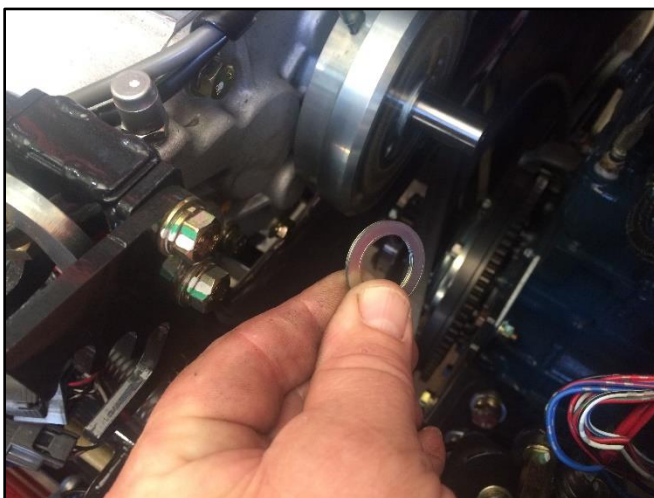
The electromagnetic clutch engages gradually in a series of pulses so as not to shock load the flexible drive cables.

If the clutch gets out of adjustment due to wear the pulses will become ineffective and the clutch will engage abruptly.

This could shock load the drive cables which could then lead to a cable failure.

As the clutch gets older it is important to adjust it to compensate for wear.

The clutch is adjusted by a series of shims between the drive pulley and the electromagnetic clutch.

When the clutch wears, shims need to be removed to allow just a very small clearance between the clutch surfaces.

To access the shims, you will need to remove the drive pulley assembly from the clutch shaft as shown.

Use a puller to remove a tight pulley from the gearbox shaft. Do not lever off the pulley as this could break the gearbox shaft.

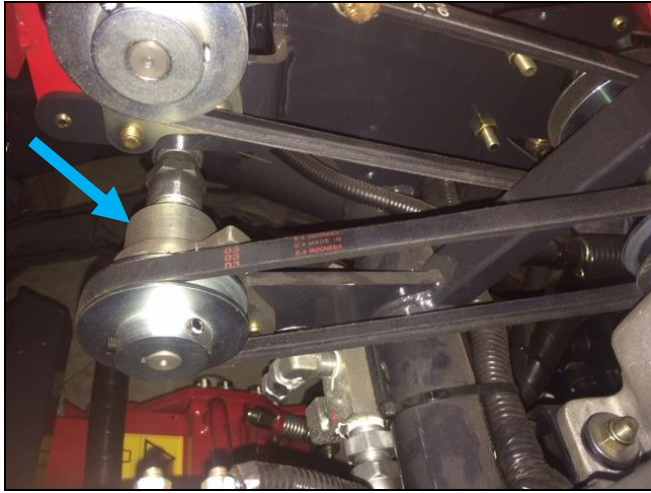
Remove 1 shim and then replace the drive pulley.

If the pulley continues to rotate freely remove another shim and try again.

Repeat this process until the clutch starts to bind. At this point add one thin shim to allow free rotation.

This setting will ensure that the clutch is not binding but with minimal clearance.

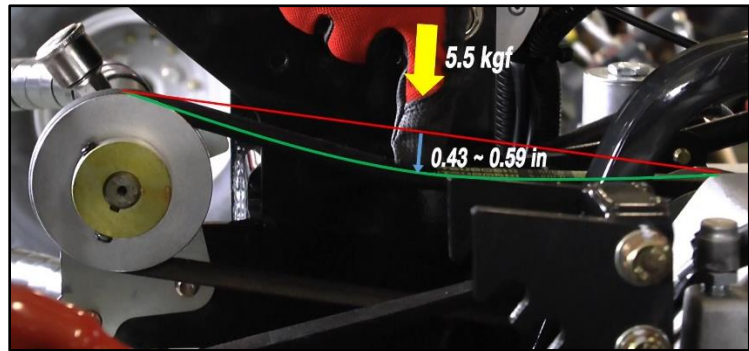
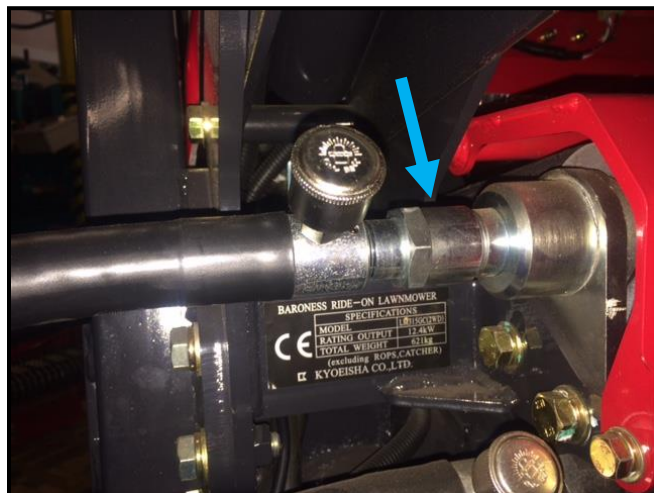
Regularly check the condition of the Belt Housing Bearings.

If these are allowed to get into a poor condition, then they could seize and stop rotating. This would result in the inertia from the cutting reel snapping the drive cable.

Never over tension the drive belts. This will increase friction which will increase heat and break down the grease within the bearings causing them to fail.

Always make sure that the cable drive belts are adjusted correctly.

5.5 kg of downwards force should deflect the belt by 11 to 15 mm (0.43 to 0.59 inches).

If you do not have the equipment to measure the downwards force then make sure that you can turn the belts through 90 degrees by using your finger and thumb.

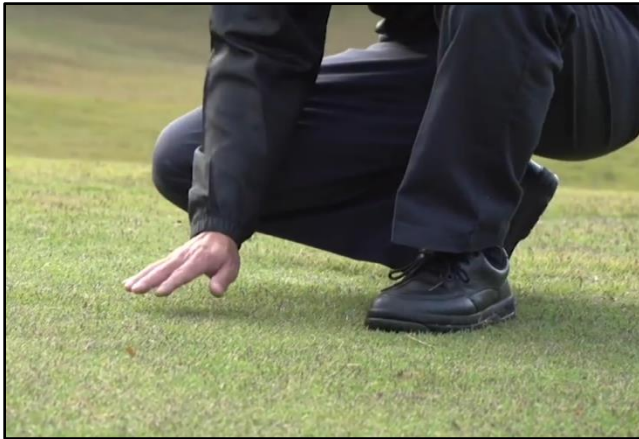
Always make sure that the outer cable retaining nut is kept tight. If it is allowed to get loose, then the flared flanged can wear through and break the inner cable.

When replacing an inner drive cable always make sure that the lining of the outer cable is not damaged as a failed inner cable can damage this liner.

If when inserting a new inner cable you feel any resistance, then the lining could be damaged.

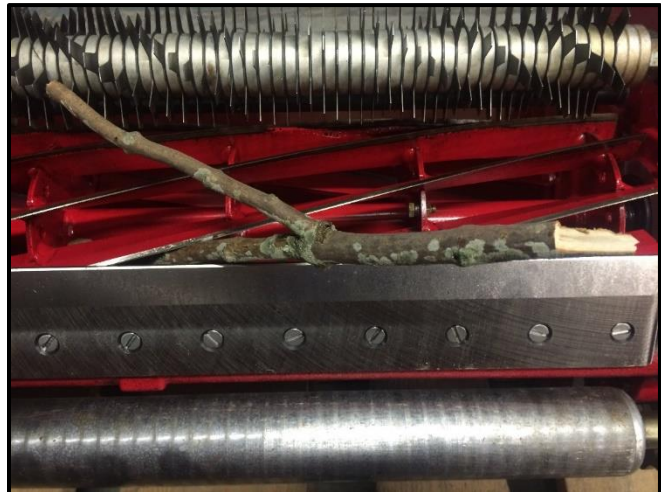
Always make sure that the golf green is in a satisfactory condition.

If the turf contains large amounts of thatch or is very wet through a lot of rain then this will cause the cutting units to sink a little lower into the green thus putting extra strain on the drive cables.

Make sure that the area to be cut is clear of debris before cutting commences.

If any debris gets caught between the reel blades, then it is possible that this could shock load and break the drive cable.
